Level II Documentation of a Segment of the Government Highline Canal (5ME4676.41) in Mesa County, Colorado

Alpine Archaeological Consultants, Inc. PO Box 2075 Montrose, Colorado 81402

Prepared for Grand Valley Water Users Association 1147 24 Rd. Grand Junction, Colorado 81505

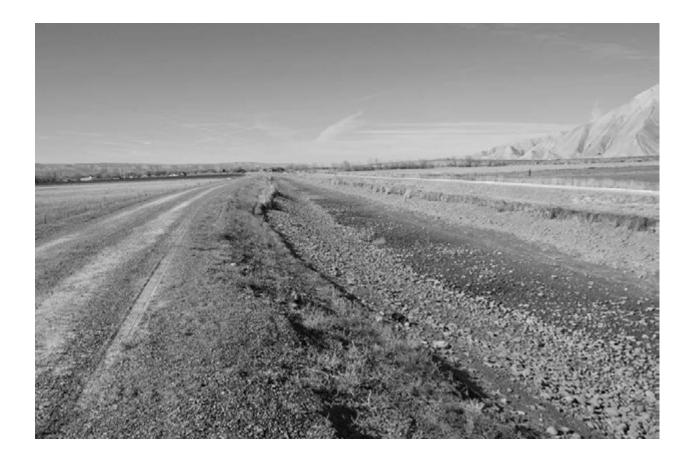
Photograph No. 1: West-facing view showing rock, rubble, and dirt-lined section of the Government Highline Canal at the western edge of the segment (5ME4676).

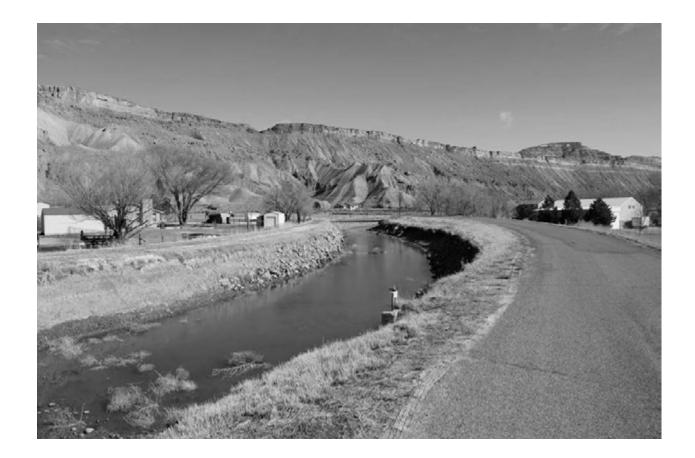
Photograph No. 2: Northeast-facing picture of the Government Highline Canal (5ME4676.41) from G 4/10 Road along the southern bank.

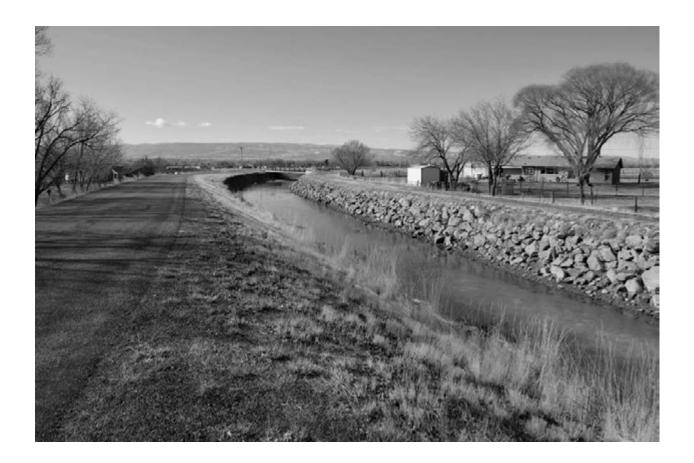
Photograph No. 3: Southwest-facing picture of the western end of the segment of the Government Highline Canal (5ME4676.41) showing rock lining on the northern bank.

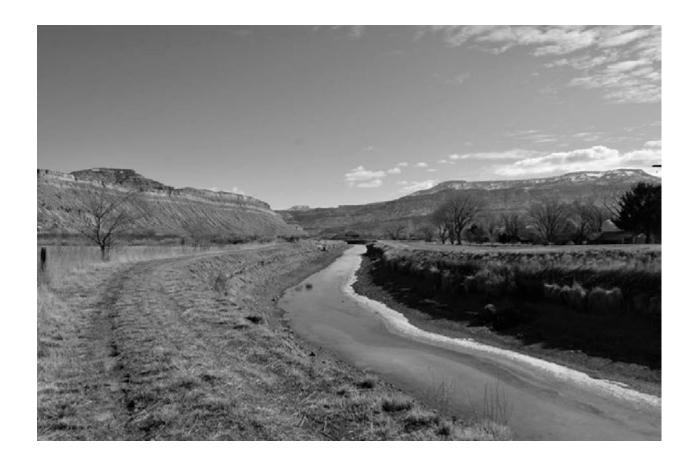
Photograph No. 4: East-facing context picture showing the agrarian setting of the southwestern portion of the segment of the Government Highline Canal (5ME4676.41).

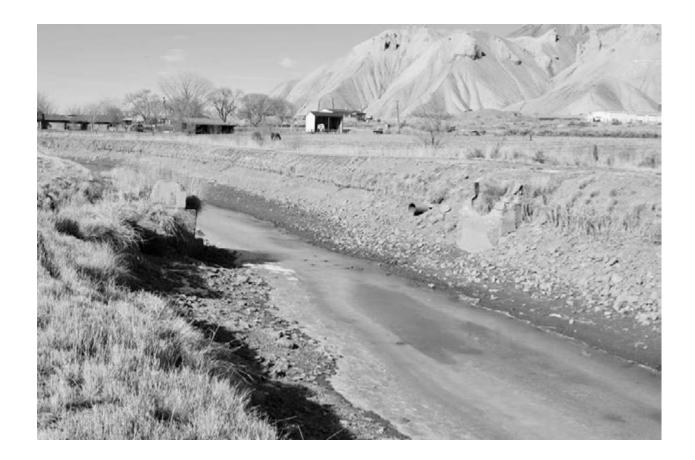
| Headgate | Description | Outflow Type |
|---|--|---|
| F1 | Two concrete flume supports on either side of the canal from a removed flume where another ditch previously crossed the Government Highline Canal. The concrete flume supports are 9 ft. wide and made from poured concrete 8 in. thick. The footings contain 6-ftdiameter semicircular depressions in the shape of the removed flume. The metal remnants of the flume are visible in the northern support, but the flume is otherwise no longer present. It does not connect to existing irrigation features on either side of the canal. | N/A |

Photograph No. 5: Feature 1, flume footings crossing the Government Highline Canal (5ME4676.41), facing northwest.

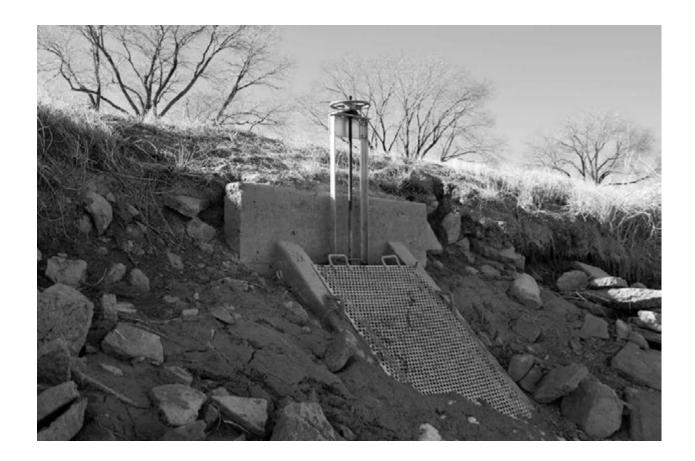
| Headgate | Description | Outflow Type |
|---|--|---|
| M6 (unlabeled) | Constructed as described in text. | 6 ft. wide concrete pipe-intake box with a hand lift gate leading to a PVC irrigation pipe. It is 2 ft. above ground surface and has an unknown depth. |

Photograph No. 6: Modern headgate M6, a representative example along the Government Highline Canal (5ME4676.41), facing southwest.

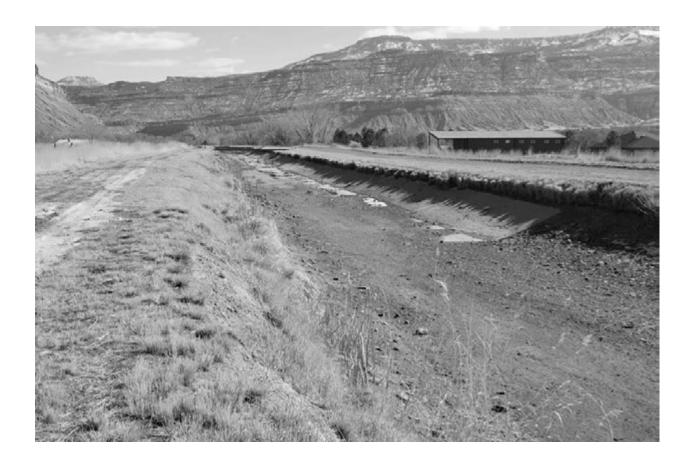
Photograph No. 7: Transition on southern bank of the Government Highline Canal (5ME4676.41) from concrete lined to dirt lined near the center of the segment, facing east-southeast.

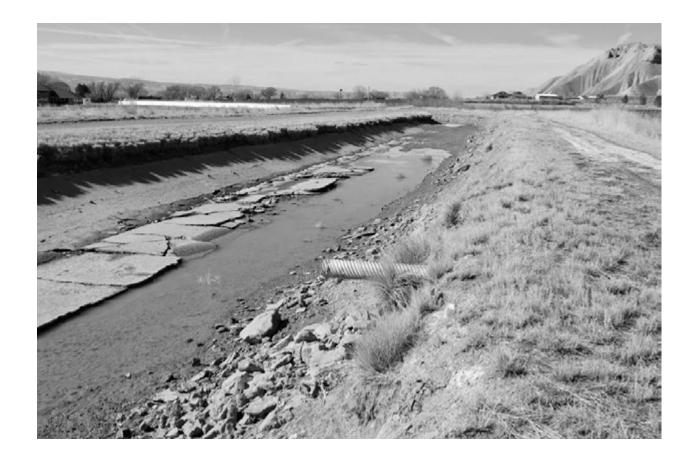
Photograph No. 8: Modern culvert draining a field into the Government Highline Canal (5ME4676.41) near the center of the segment, facing west.

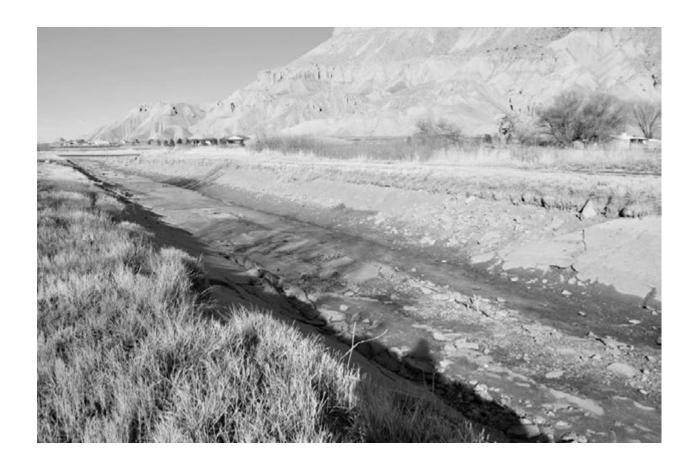
Photograph No. 9: West-facing context picture showing the central portion of the segment of the Government Highline Canal (5ME4676.41) with nearby houses and the Book Cliffs in the background.

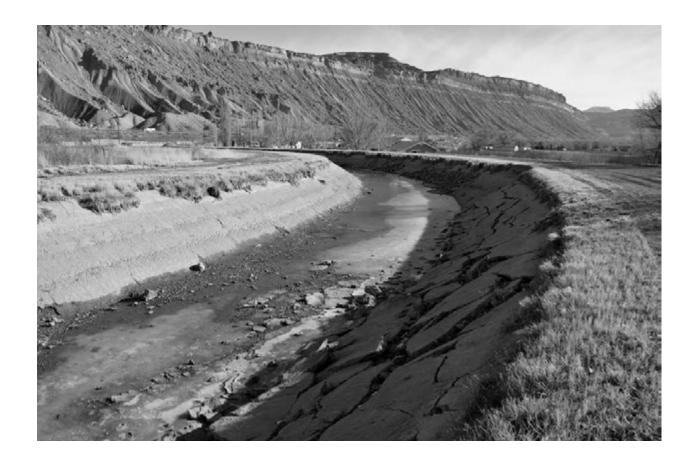
Photograph No. 10: East-northeast-facing picture of the Government Highline Canal (5ME4676.41) showing cracked concrete lining near the center of the canal.

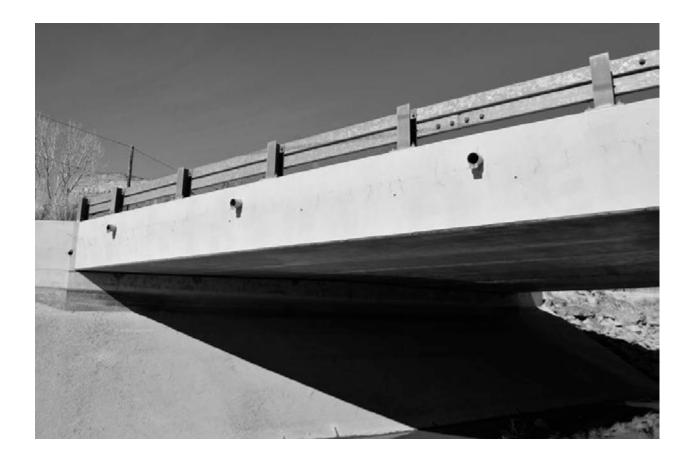
Photograph No. 11: Modern shotcrete lining beneath the bridge crossing of G 7/10 Road over the Government Highline Canal (5ME4676.41), facing north.

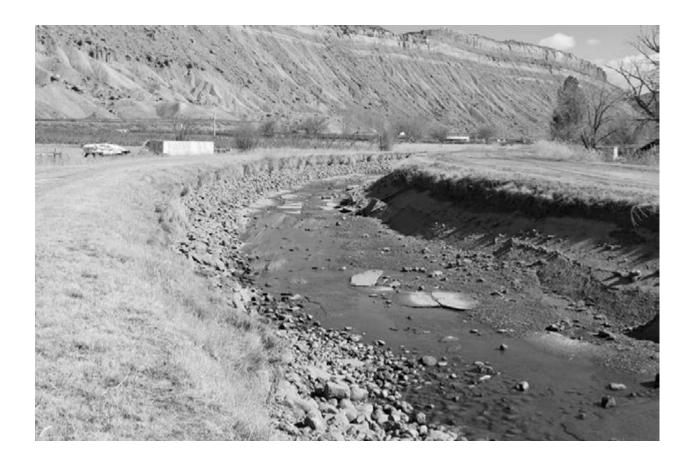
Photograph No. 12: East-northeast-facing view of the Government Highline Canal (5ME4676.41) where it is rubble lined on the northern bank and concrete lined on the southern bank.

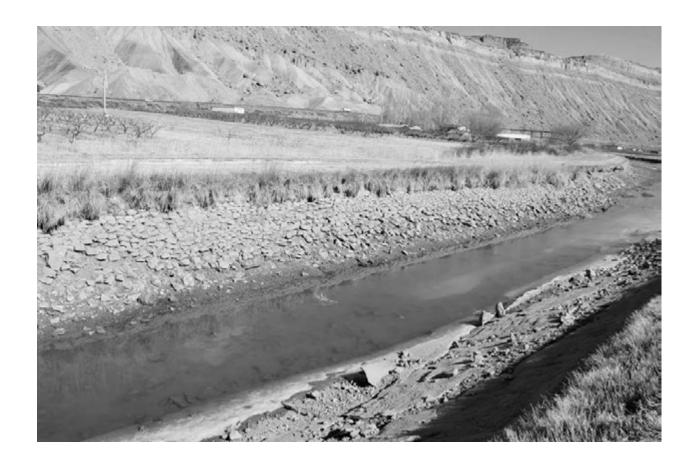
Photograph No. 13: Northeast-facing view of rock masonry lining on a 75-m-long segment of the Government Highline Canal towards the eastern edge (5ME4676.41).

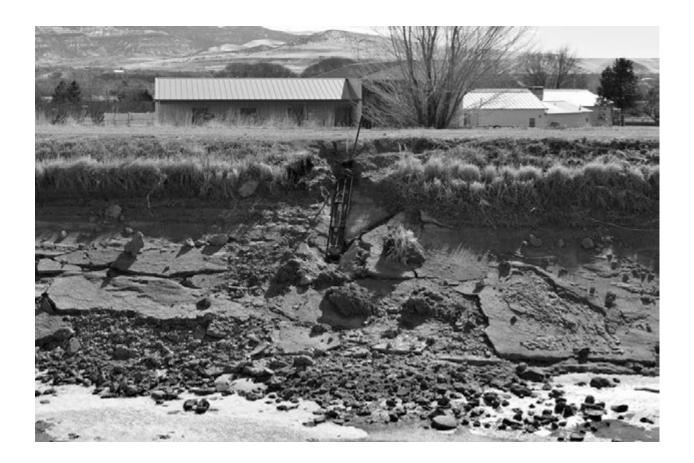
| Headgate | Description | Outflow Type |
|---|--|---|
| M2 | The only headgate with different construction. It was laid along the canal edge at a 45-degree angle with no headwall or protective structure. It feeds into a ceramic pipe with its edge cut at an angle. The sediment around the top has been removed so that it still functions. | Leads into a mixture of concrete sluices, metal, and PVC pipes that are informally organized and modern. |

Photograph No. 14: Headgate M2, the only leaning gate without a headwall along the Government Highline Canal (5ME4676.41), facing northwest.

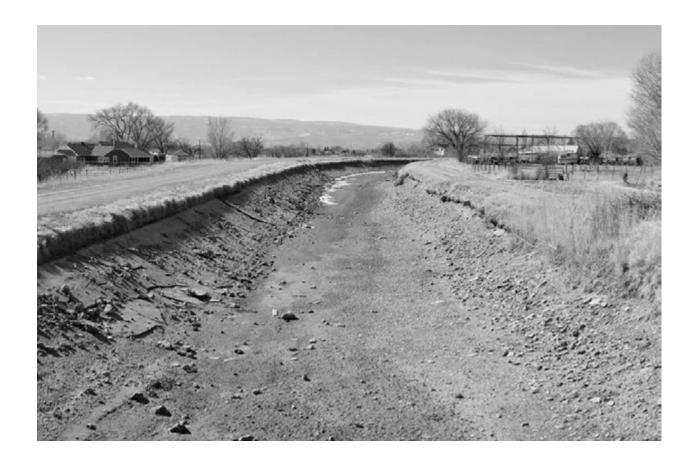
Photograph No. 15: Southwest-facing view of the Government Highline Canal (5ME4676.41) showing the eastern edge of the recorded segment.
